UNITED STATES
DEPARTMENT OF THE INTERIOR
BUREAU OF MINES

Welch, West Virginia
February 12, 1959

Subject: Report on investigation of miner coal outburst (bump), Mary Helen No. 3 mine, Mary Helen Coal Corporation, Coalgood, Harlan County, Kentucky

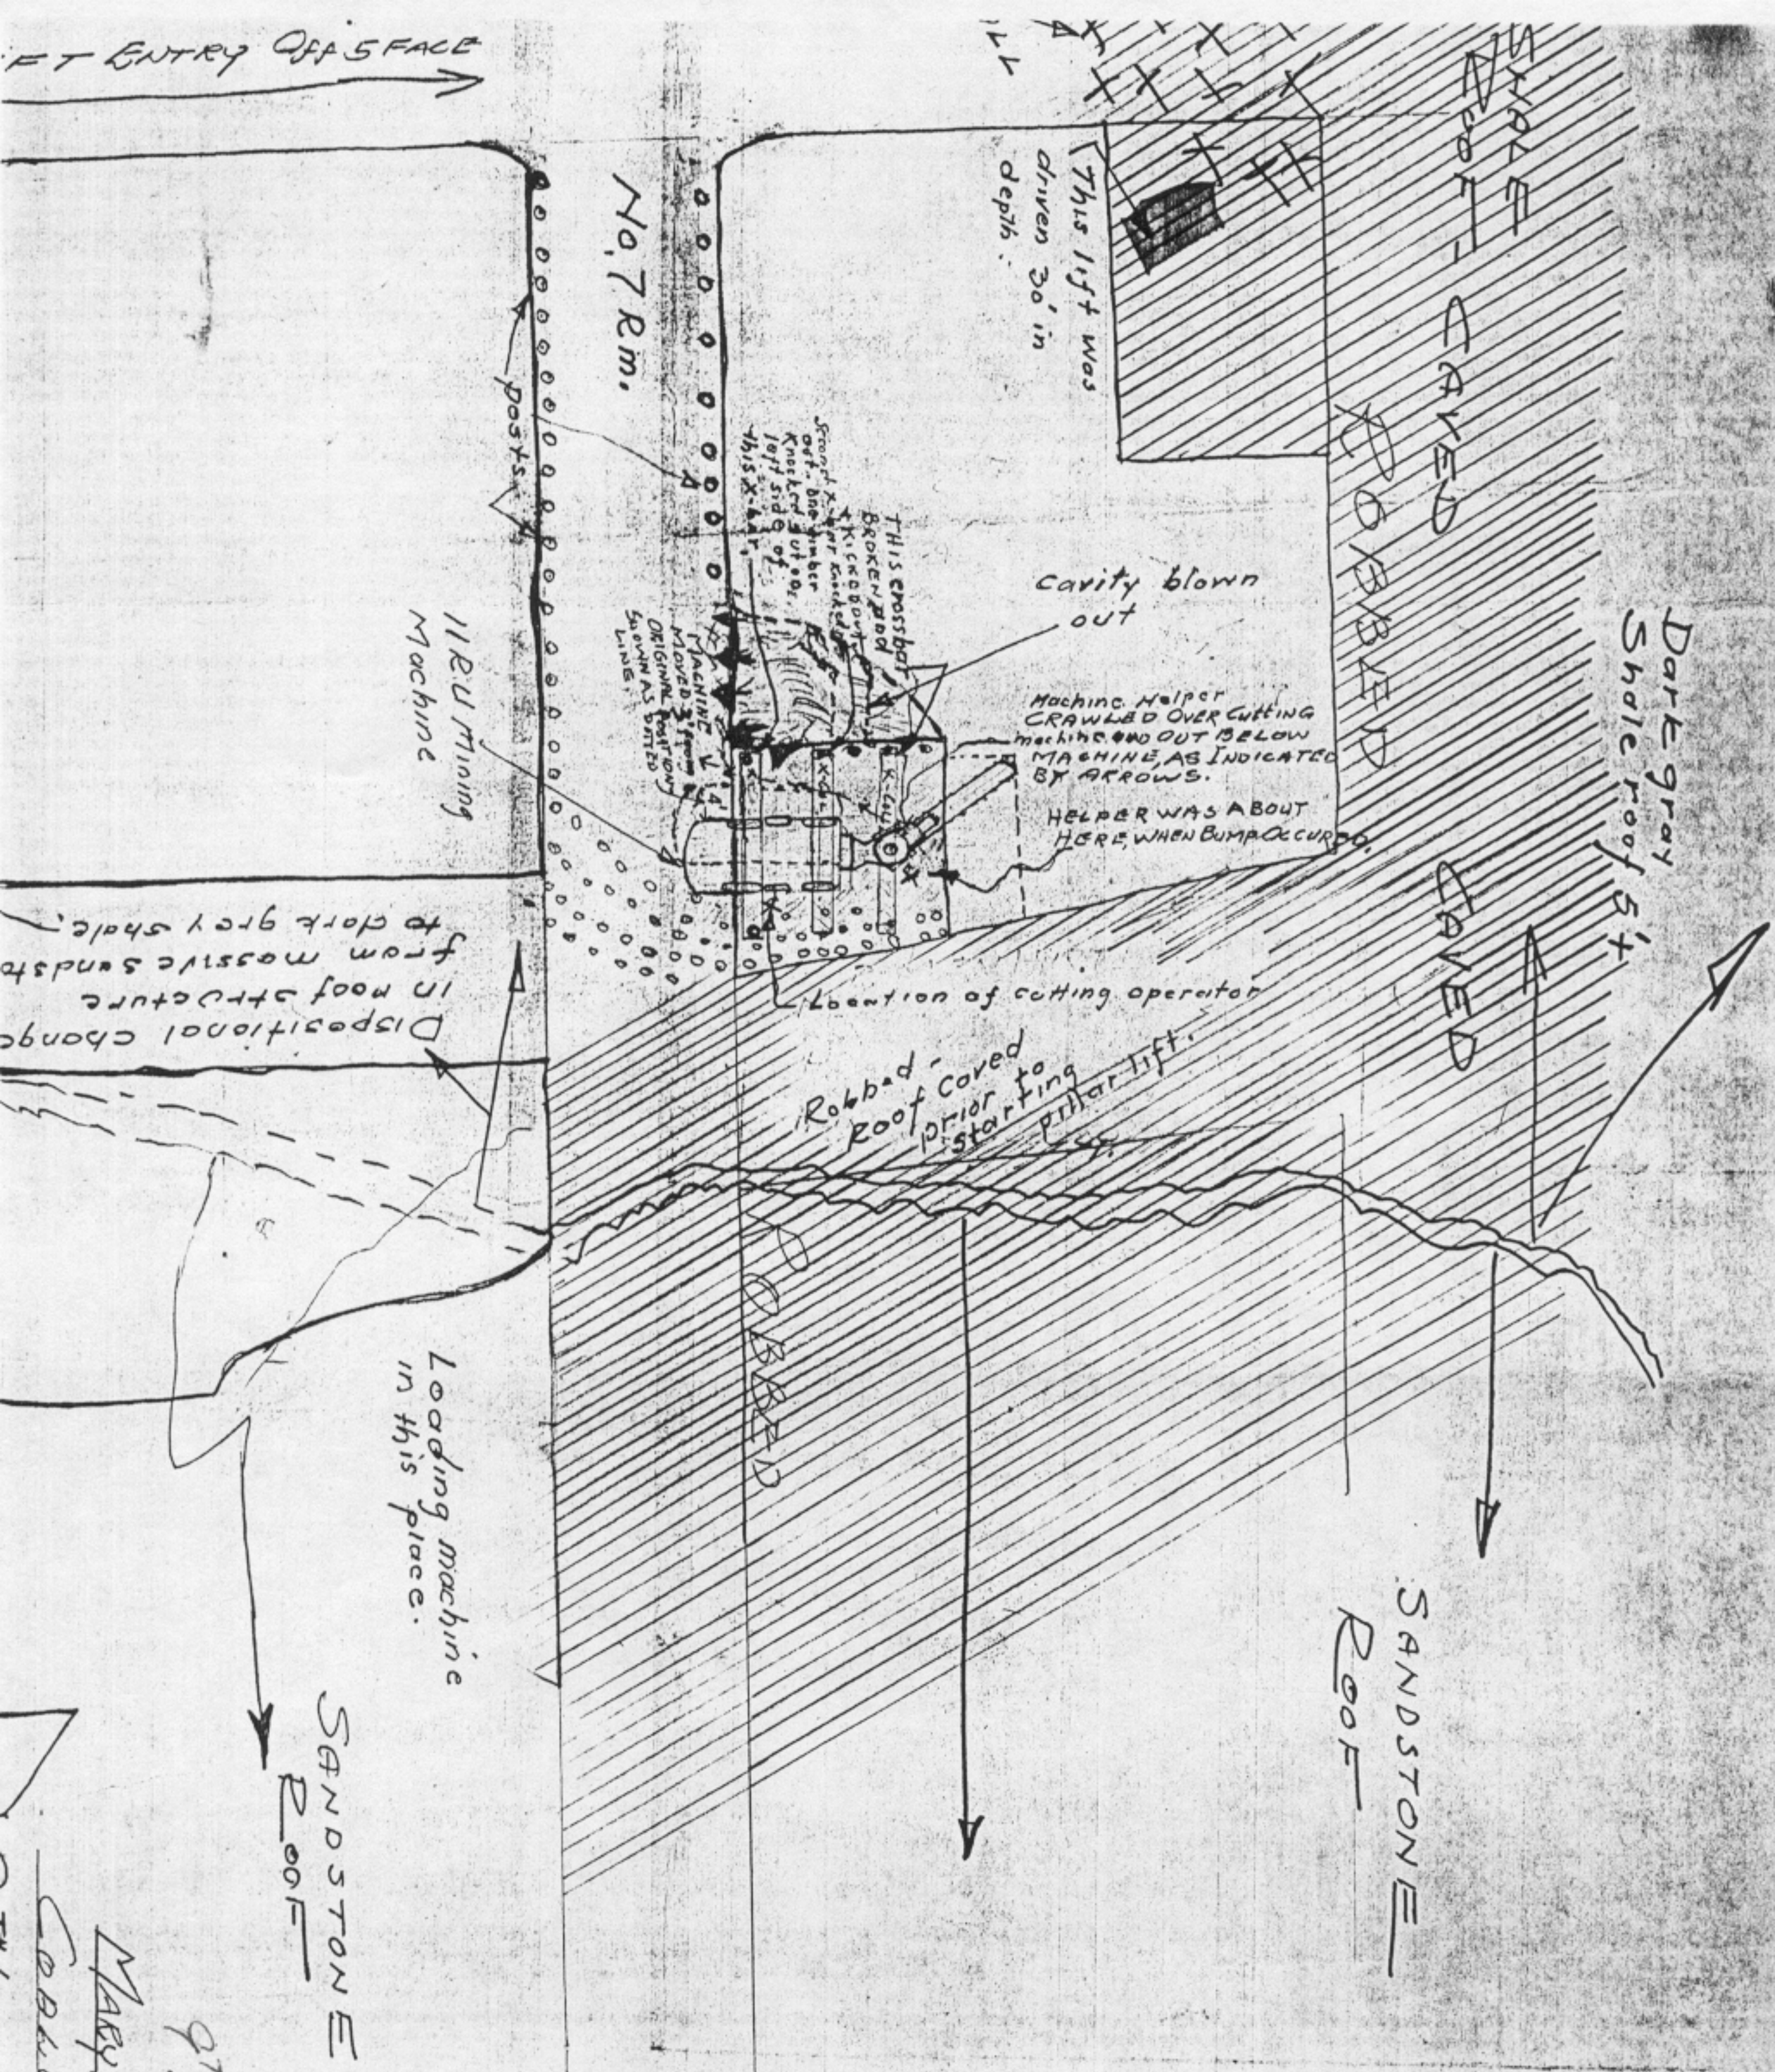
Sketch No. 1

The reaction of the outburst forced the cutting machine sidewise (jack-knife fashion) about 3 feet and about 12 tons of coal was thrown from the coal rib but none was thrown from the face of the lift. Most of the coal it will be noted, was thrown outward from the corner of the pillar (at the entrance to the lift) and a cavity about 1-1/2 feet in diameter extended about 8 feet within the pillar. This cavity evidently was the result of the comparatively violent expulsion (outward movement) of the coal at the corner of the pillar lift. The roof in the immediate vicinity of the outburst was not shaken down or detached, but several cracks opened in the roof in the pillar lift involved and a lesser number were observed in the adjacent No. 6 room pillar. There were three crossbars in addition to posts set according to plan in the pillar lift. One crossbar was broken, one was dislodged, and a timber was knocked from under the end of the third crossbar by the outrush of coal and/or forces. Damage to the cutting machine consisted of a burst hydraulic hose, a bent boom-swing-jack piston rod, and a broken cutter-chain adjustment bolt. Reportedly, gas was not detected with a flame safety lamp and the electric power was cut off immediately after the outburst.

THIS crossbar
BROKEN AND
KICKED OUT
of. One member
knocked out of
left side of
this machine.

SCENE OF
 OUTBURST
 No. 7 ROOM
 9 LEFT 5 FACE
 SOUTH

3. Sufficient cribs, in conjunction with other roof supports, should be used to support the roof and keep the roadways or passageways to the pillar workings open and in safe condition. (It is believed that if the first pillar lift from the entry side had been completed, the outburst likely would not have occurred.)
